Causal Analysis of the Pinion Teeth Failure in a Limestone Reclaimer

L M Castellanos^{1*}, J J Cabello², A Sagastume², V L Martínez¹ and A E Ortiz³

Abstract. This paper presents a causal analysis of an unexpected failure of the pinion teeth of a large reducer installed in a limestone reclaimer which is part of a raw material transportation system of a cement factory. The Montano methodology is applied. It includes a collection of documentation, evidences, evaluation of failure mechanism by visual inspection and some hypothesis and their validation based on the analysis of the material resistance. It is demonstrated that although the teeth of the pinion were made of a suitable material and cemented correctly, they worked overloaded due to the presence of large rocks in the raw material. A resulting increase of contact tensions in the teeth over the allowed limits led to a fatigue failure process which is described in this work. The results of the analysis can be of great interest in order to develop preventive measures and avoid future undesired plant stoppages and economic losses.

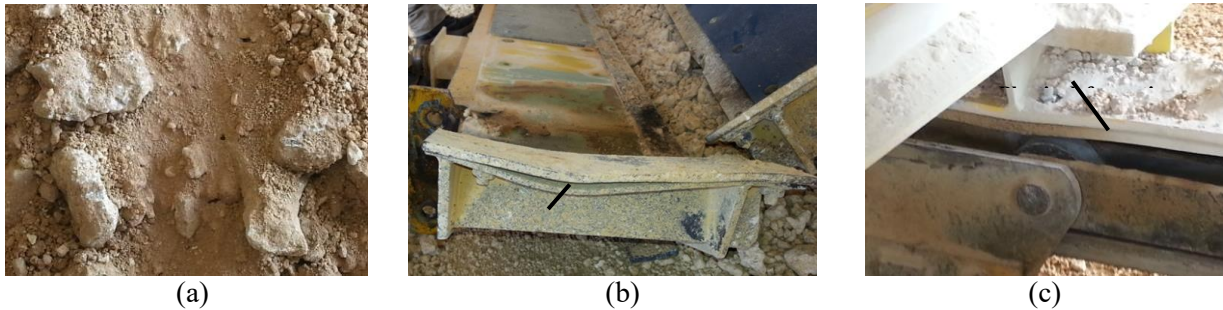
Figure 3. Operational conditions of push device

The service regime of the push mechanism is very hard because of frequently big rocks in the limestone as can be seen in figure 3 (a) provoking dynamics loads which deform tablets and structure of the rake arm as are shown in figure 3 (b) and (c). Also the chain wear increases the dynamic loads.

In visual inspection, the damaged gears were carefully examined in order to identify the failure mechanism. Large stones are observed in the raw material and plastic deformation in the steel structure and tablets

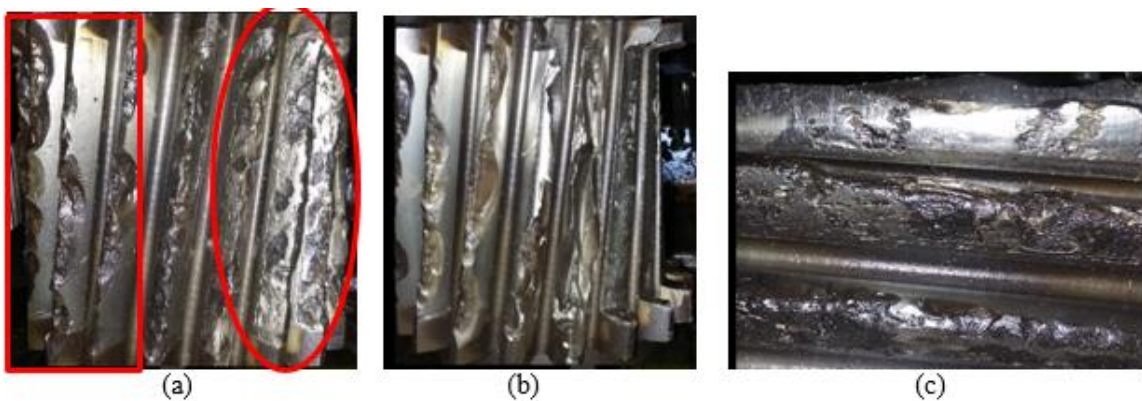
Figure 4. Visual inspection of the pinion teeth.

In figure 4 some pictures of the failure in the pinion are shown, the failure of the gears pair is mainly in the pinion. In figure 4 (a) the circle marked teeth surfaces show pitting and micro-pitting failure mode with scales removed, on teeth surfaces mark by box, which are on the teeth back, some fragile fractures are observed through the surface. In figure 4 (b) the highly destructive character of the failure is shown and two teeth fully removed from the pinion are shown, evidenced the effects of the high overload level produced by the progressive spoilage the teeth profile and also by the external dynamic load action. The tooth before the completely removed teeth has a large significant loss of material. Figure 4 (c) show a best picture of the mass loss in the work tooth flanks are shown. No significant evidence of wear or plastic deformation was found on any affected teeth.

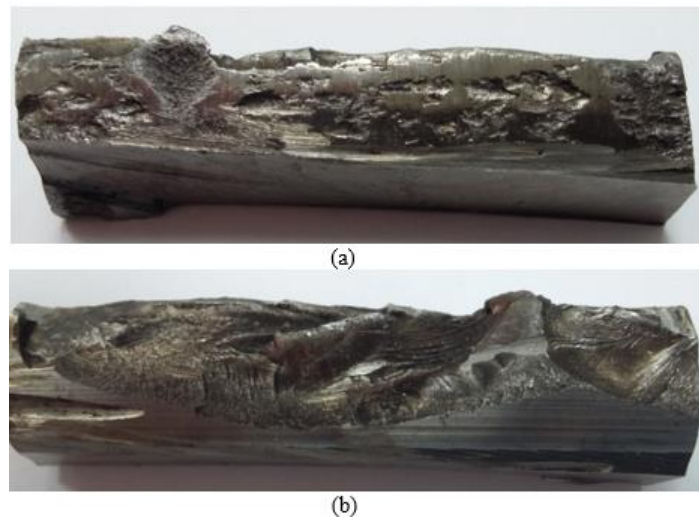
Figure 5. Macroscopic study (25 X) on the tooth surface, (a) work surface y (b) back surface

The fractographic study was carried out on both sides of the tooth as are shown in figure 5 (a). The behaviour is typical of this kind of failure with micropitting at the beginning and progressive pitting and lost large part of the surface with the consequent increase of surfacing stress and removing scales from the surface until its destruction. In figure 5 (b) a fractographic study of the tooth back surface is shown, the high level of destruction of work surface and the dynamics loads cause the extension of fragile fracture to this surface destructing.

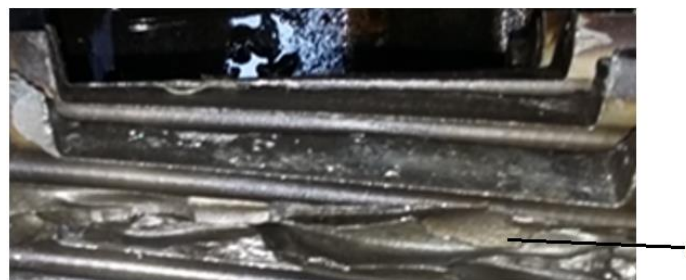
Figure 6. Removed teeth

Surface fatigue in the closed gears is not easily detected and have a trend to worse because of the growth of contact stresses and the presence of metal's fragments detached from teeth surfaced which introduce additional loads which contribute to fracture by the base of other teeth. When a tooth is broken by a sudden shock or an overload, the fracture usually has a fibrous appearance, even when the tooth is fully hardened, the fracture will look like the fibers of a plastic material that has been twisted [4]. When consecutive teeth are broken, it usually happens that one or two are broken by fatigue; As the gear continues to rotate under torque, the hit of the wheel that meshes when jumping into the gap left by the fatigued tooth will break other additional teeth. Looking at several fractured teeth, one can define which one failed due to fatigue (it will present a smooth appearance) and which failed later due to overload (fibrous appearance). This phenomenon is manifested in figure 6 where a detail of removed teeth are shown, in which the tooth-marked No 1 was fractured by fatigue and those on the right of this failed due to overload, in the absence of tooth No 1.

The more probable cause of failure in the pinion is the overloads and high contact stresses, which increase significantly with the degree of deterioration. The failure begins with superficial fatigue, progressive pitting and scaled; then the volumetric fatigue fracture is caused in the base of one or two teeth and the lack of these, the inertia and the torque of the motor cause the fracture by the base of several contiguous by overload and impact.

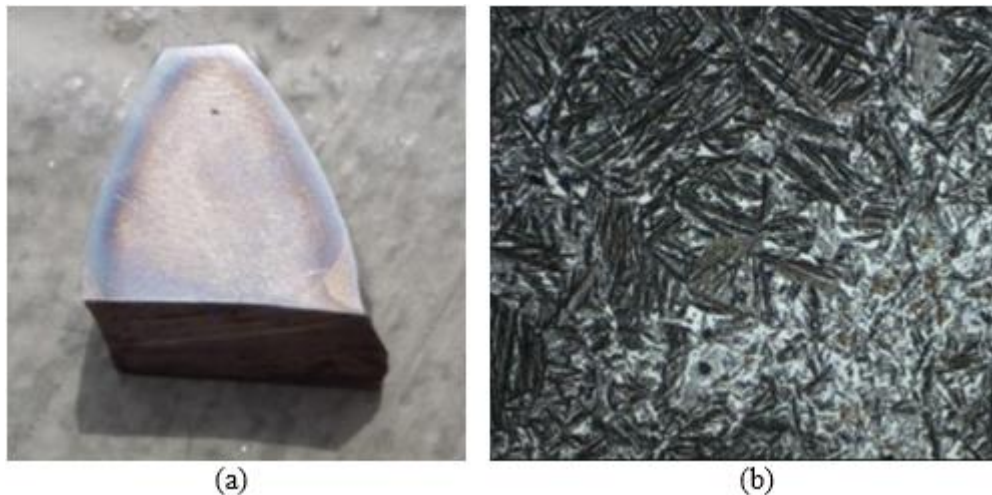
Figure 7. Tooth section (a) macro structural analysis and (b) microstructure showing martensite

In figure 7 (a), a specimen from a pinion tooth taken from lateral side which not contact con crown tooth is shown, used for macrographic analysis, hardness measurement and micrographic analysis. The macrographic analysis of polished area evidenced two zones, one peripheral, around 1,3 to 1,6 mm, where the surface is darker as a result of the chemical attack with Nital at 3 % and other inside the tooth clearest. The structure is typical of cemented steel which is corresponding with hardness measures the 60 HRC in surface and 45 HRC below the cemented layer. Additionally, the micrograph of the surface layer in figure 7 (b) shows martensite with low tempering, typical of the cemented and tempered. It should be noted that the steel is of very good quality due to the degree of cleaning, there is a low level of non-metallic inclusions, in the form of oxides.

The results let concluded that that the Pinion was cemented, with posterior tempering, with a core (inside the tooth), for its chromium and nickel levels the inside of the tooth hardens enough (45 HRC), limited by the Low carbon inside (0.16 % C), giving rise to a tempered martensitic of medium hardness. In contrast, the surface has high hardness (60 HRC) due to the martensitic rich in carbon and chromium. In addition, small grain size is evident, which is desirable.

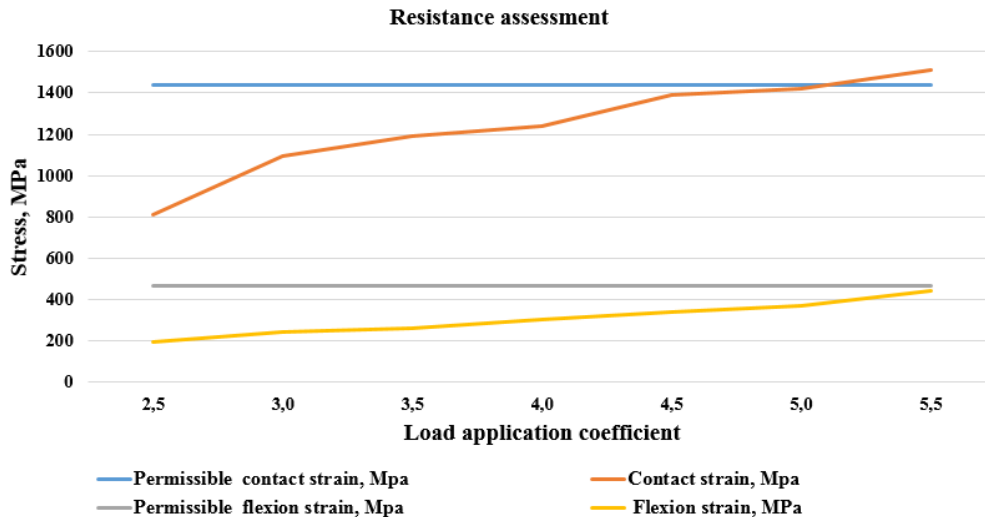
Figure 8. Mechanical resistance assessment results

As the operating regime of the chain and the push plates driven by the reducer is heavy collisions, the verification calculation consisted in calculating the contact and bending stresses at the foot of the tooth and the admissible tensions for values of the Load application coefficient between 1.5 and 5.5. The results are shown in figure 8.

In figure 8 can be seen that values of the load application coefficient below 3, the safety coefficient to the pitting is greater than 1.5; nevertheless, with values close to 5 the superficial stress exceeds the admissible stress of the material and the useful life of the gears must be shortened significantly. The bending stresses at these coefficient levels are remarkably close to the allowable stresses even without taking into account the effects of the destructive pitting on the profile of the teeth.

From the analysis, is possible concluded that the pair of gears is well designed and can have a useful life of the order of 20 000 hours considered in the verification calculations, the cause of the failure is the conditions of severe dynamic loads to which is subjected to the operating conditions of the mechanism that triggers.
